Emergency Response Section - District Office Investigation Report (DOIR)

Spill Id Number: 0812-02-4523

Incident # 0812-02-4523
Southern Illinois Railcar
Ammonia Waste runoff
OSC Gerber, 12/03/2008

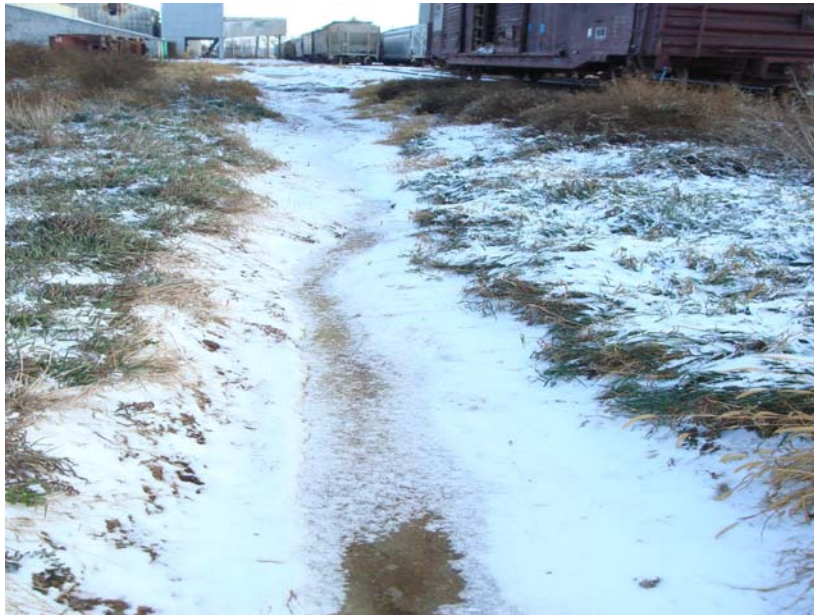
12/2/2008 12:03:29 PM 0812-02-4523

Permanent Description: Drainage ditch flowing to balck tile discharging into SR 65 sewer line upstream of gasoline tanker release. Ammoia reading found to be over 1200 ppm.

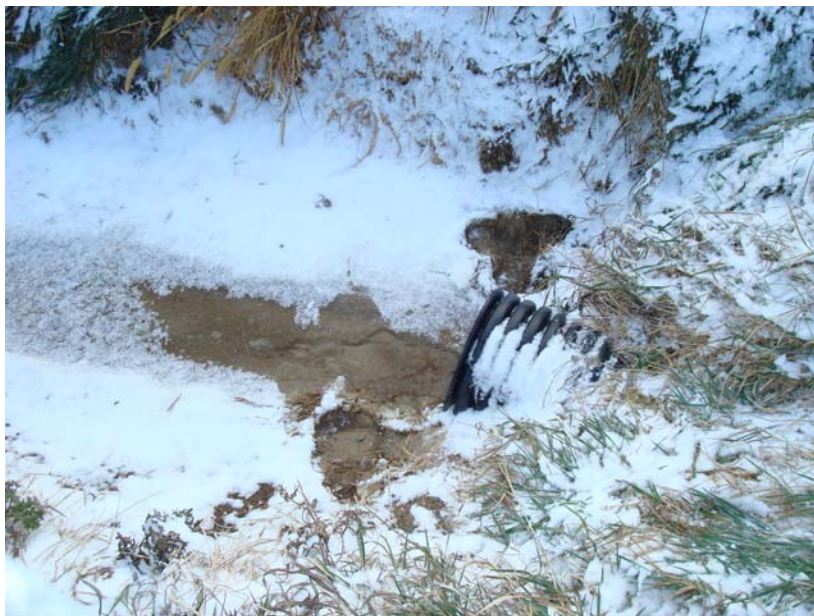
12/2/2008 12:03:20 PM 0812-02-4523

Permanent Description: Drainage ditch flowing to balck tile discharging into SR 65 sewer line upstream of gasoline tanker release. Ammoia reading found to be over 1200 ppm.
